输送设备验收报告

Acceptance report, conveyor system, MA-02

对象 Subject	1 台辊道输送机，6 米，带防护栏和操作台 1 roller conveyor, 6 m, with guard fence and operator panel
委托方 Client	Muster Maschinenbau GmbH (虚构)
制造商 Manufacturer	Przykład Sp. z o.o. (虚构)
地点和日期 Place and date	波兹南，04.03.2026 Poznań, 04.03.2026
依据 Basis	订单、布置图 B 版、技术规格书 Order, layout drawing revision B, specification
在场人员 Present	制造商项目负责人和装配人员，Office-Remscheid Manufacturer's project lead and fitter, Office-Remscheid

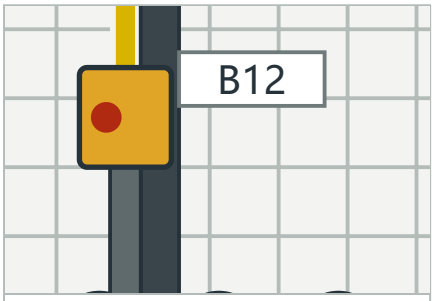
C2 光电开关 B12 标识与图纸一致
Light barrier B12 labelled as in the drawing

C3 按钮为德文，显示屏仍为波兰文
Buttons in German, display still in Polish
