控制柜验收报告

Acceptance report, control cabinet, MA-01

对象 Subject	1 台控制柜，1200 × 800 × 300 毫米，带控制器 1 control cabinet, 1200 × 800 × 300 mm, with controller
委托方 Client	Muster Maschinenbau GmbH (虚构)
制造商 Manufacturer	Przykład Sp. z o.o. (虚构)
地点和日期 Place and date	视频预约，波兹南工厂，04.03.2026 Video appointment, plant in Poznań, 04.03.2026
依据 Basis	订单、电路图 D 版、布置图、零件清单 Order, wiring diagram revision D, layout drawing, parts list
在场人员 Present	制造商项目负责人和装配人员，Office-Remscheid Manufacturer's project lead and fitter, Office-Remscheid

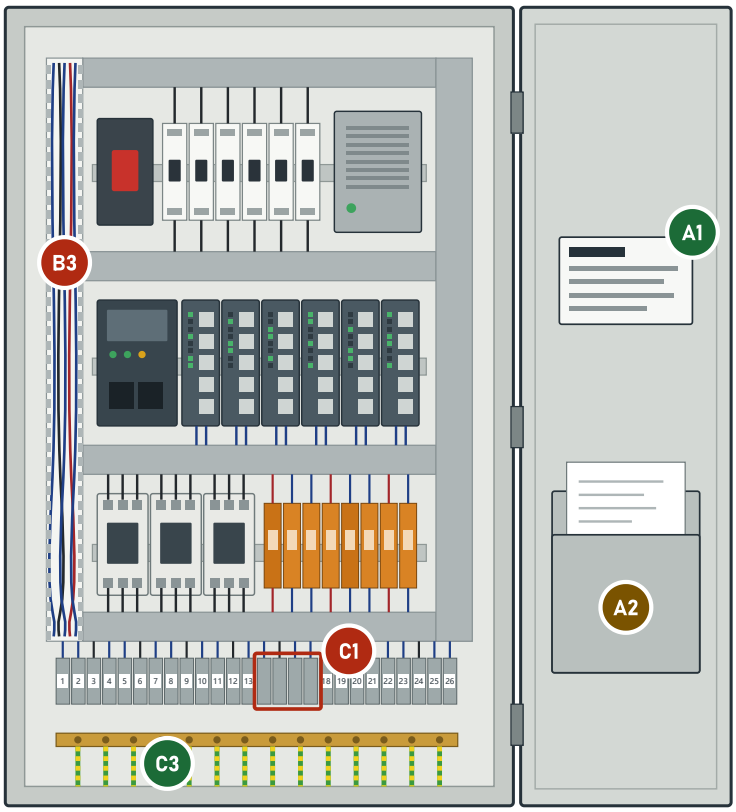
检查点位置 Location of inspection points

编号	检查项 Item	制造商答复 Manufacturer's reply	期限 by
B3	左侧线槽没有盖 Left cable duct has no cover	盖已裁好，测试后装上 Cover is cut to size and will be fitted after the test	06.03.2026
B5	底部缺少一个 M25 堵头 One M25 blanking plug missing in the base	堵头有库存，将装上 Plug is in stock and will be fitted	06.03.2026
C1	14 至 17 号端子缺少标签 Labels missing on terminals 14 to 17	标签将重新打印 Labels will be reprinted	06.03.2026

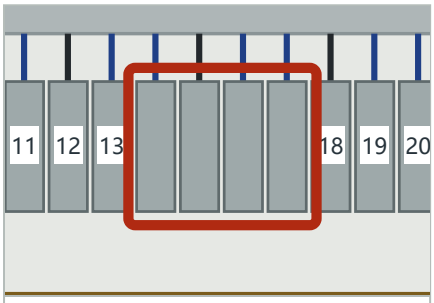
编号	检查项和结果 Item and finding	结果 Result
B2	柜体和漆面无可见损伤 未见损伤，视频中展示了所有侧面 No damage visible, all sides shown on video	**合格** OK
B3	所有线槽都有盖 左侧线槽没有盖 Left cable duct has no cover	**未完成** Open
B4	器件标识清晰 抽查的器件均有标识 All devices in the sample are labelled	**合格** OK
B5	柜体上未用的孔已封闭 底部缺少一个 M25 堵头 One M25 blanking plug missing in the base	**未完成** Open
接线 Wiring		
C1	端子有标签 14 至 17 号端子缺少标签 Labels missing on terminals 14 to 17	**未完成** Open
C2	线号：抽查 20 根线 20 根线全部与电路图 D 版一致 20 of 20 wires as in wiring diagram revision D	**合格** OK
C3	保护导体已接到 PE 排 可见所有保护导体均接到 PE 排 All protective conductors visibly connected to the PE bar	**合格** OK
C4	柜门已接保护导体 导线已安装，两端均已连接 Conductor fitted and connected at both ends	**合格** OK
制造商演示 Demonstration by the manufacturer		
D1	控制电压，记录制造商的读数 24.1 V DC，由制造商测量 24.1 V DC, measured by the manufacturer	**合格** OK
D2	输入输出：查看 12 个信号 12 个信号均在显示中看到 12 of 12 signals seen on the display	**合格** OK
D3	演示急停回路 未演示，按钮未连接 Not demonstrated, the button was not connected	**未演示** Not demonstrated

B3 左侧线槽没有盖
Left cable duct has no cover
