包装与装车报告

Packing and loading report, MA-04

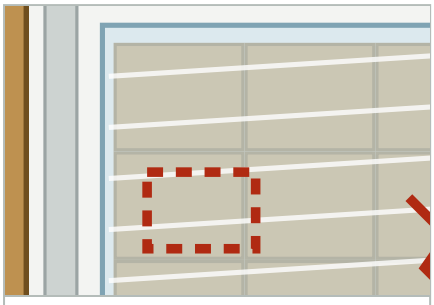
B2 第 3 件没有标签
Package 3 has no label

编号	检查项和结果 Item and finding	结果 Result
文件 Documents		
A1	按装箱单清点件数 3 件全部到齐 3 of 3 packages present	**合格** OK
A2	运单已填写 CMR 运单已填写，副本见附件 CMR consignment note completed, copy attached	**合格** OK
A3	查看验收未完成事项 3 项均可见已完成 3 of 3 items visibly closed	**合格** OK
包装 Packing		
B1	木箱无可见损伤 未见损伤，已拍摄所有侧面 No damage visible, all sides photographed	**合格** OK
B2	每件都有标签 第 3 件没有标签 Package 3 has no label 制造商答复: 出发前已贴标签，见照片	**已现场解决** Fixed on site

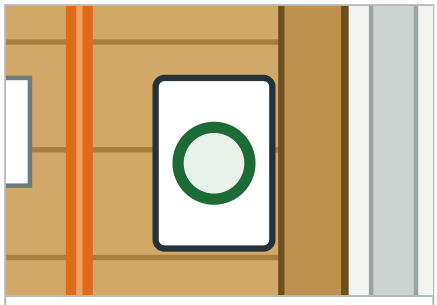
B4 2 号箱上有倾斜指示器，未触发
Tilt indicator on crate 2, not triggered

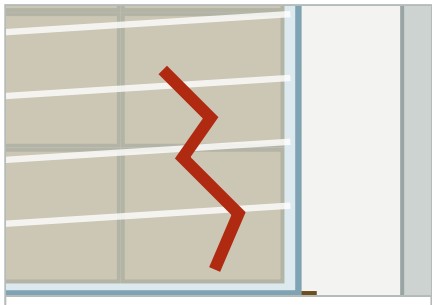
All three packages were loaded, the truck left at 14:20. Before departure one label and one edge protector were missing, both were added on site. The film on package 3 is torn.

B5 第 3 件的薄膜有破损
Film on package 3 is torn

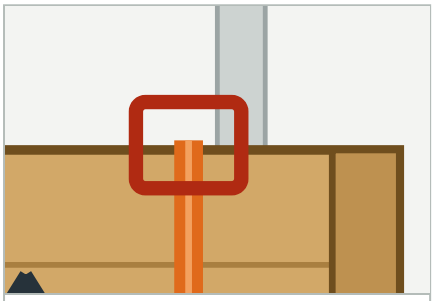
C2 1 号箱右侧绑带下缺少护角
Crate 1: edge protector missing under the right strap

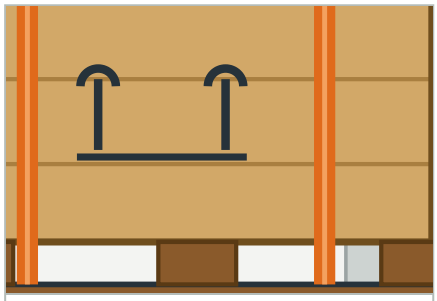
C3 1 号箱在标记点起吊
Crate 1 lifted at the marked points
